While Underway at Crooked Harbour, the Local Wooden Cargo Vessel M20187A Collided with the Police Patrol Launch, Police 44

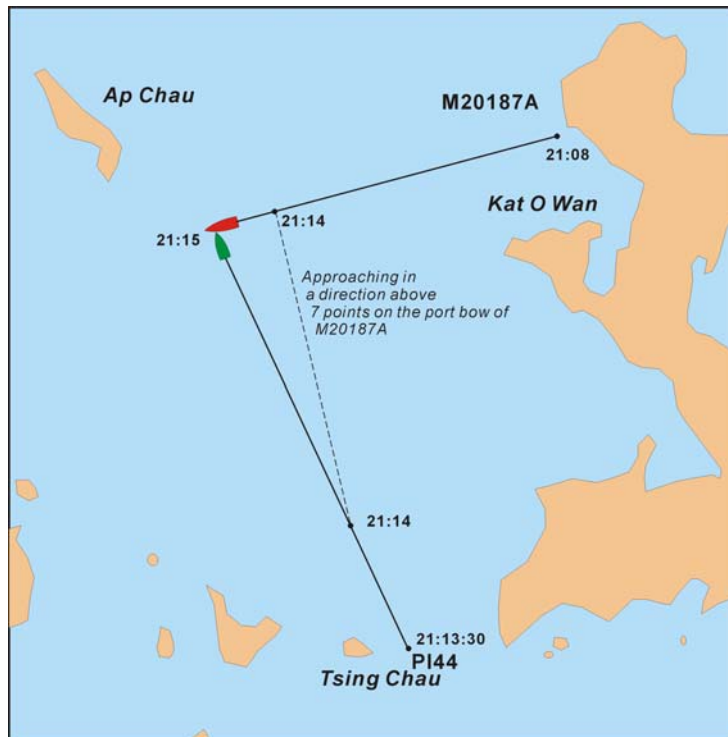
1. At about 2115 on 25 June 2003, the local wooden cargo vessel M20187A, while underway at Crooked Harbour, collided with the police patrol launch, Police 44 at the approximate position of 22^o-32.93'N, 114^o-16.49'E, southeast of Ap Chau (Figure 1).
2. At the time of the accident, the weather conditions were cloudy with light wind and the visibility was about 10 miles.
3. The hull and superstructure of the Cargo Vessel were seriously damaged. PL44 also sustained considerable damages to its hull. The master of the Cargo Vessel and 4 policemen on board PL44 were injured.

Figure 1 Sketch showing the estimated tracks of PL44 and M20187A

1. Proper look-out should be maintained at all time, especially in hours of darkness.
2. The vessel should be operated at a safe speed prevailing to the circumstances.
