**Whilst plying on foilborne mode from Hong Kong to Macau, the jetfoil Sao Jorge (銀星) encountered bad weather and was brought down on hull in the approximate position of 2 miles east of Siu A Chau North Buoy.**

**A. The Incident**

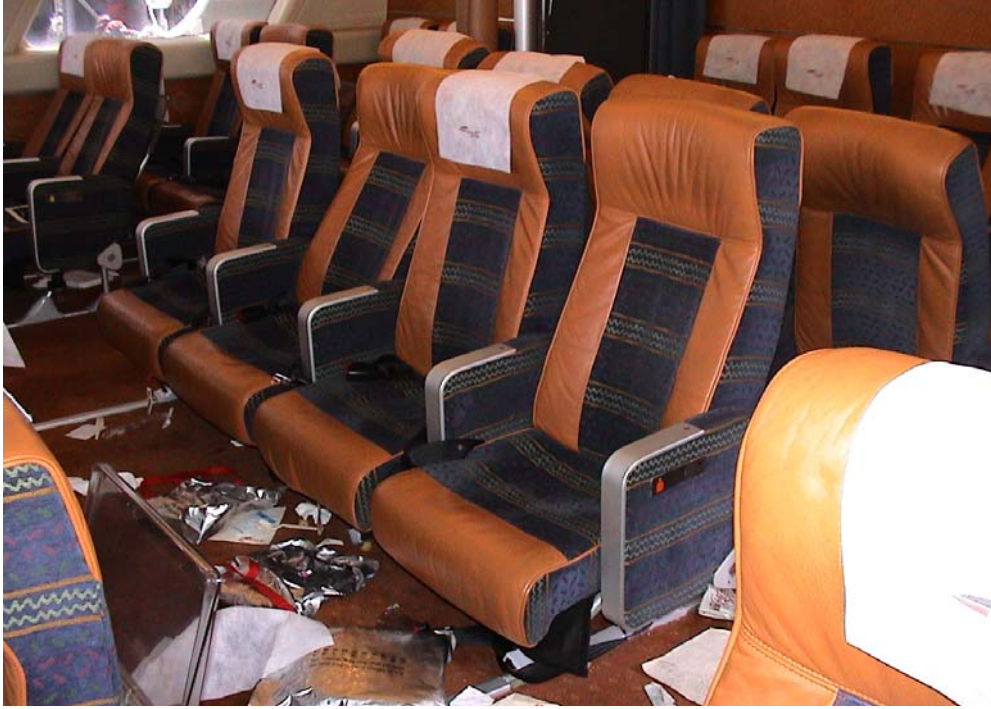
1. The investigation identifies the most probable cause of the sudden brought down on hull of the craft and the subsequent failure of the passenger seats was due to the craft had been operating in adverse sea conditions with a sudden onset of a large wave.

Figure 1 The damaged Passenger seat of Sao Jorge (銀星)

1. Subsequent to cancellation of typhoon signals, in the areas exposed to the open sea, the sea condition may continuously be subject to gale force wind over a prolonged period. The consideration in maintaining or resuming services provide by high speed passenger craft after typhoon passage could not be relied on the weather warning signals alone. High speed craft operators should obtain as much relevant weather information as possible and carry out a proper assessment on such information for safe navigation.
