## **A PRC Registered Coastal Vessel “利興順” Foundered and Sank East of Wong Nai Chau (黃泥洲)**

### **A. The Incident**

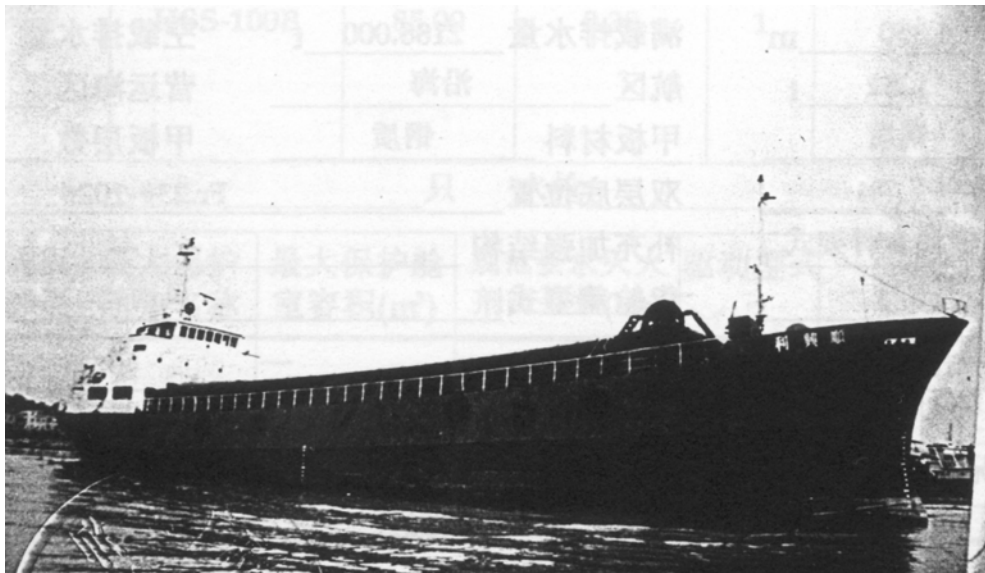
Fig. 1 A photo of “利興順”

In the early morning of 19 December 2003, while on passage from Hong Kong to Shantou, the People’s Republic of China (PRC) registered coastal vessel “Li Xing Shun” (利興順) (Fig. 1) capsized and sank in the approximate position 22° 21.'56N 114° 27.'69E, at about 4 nautical miles east of Wong Nai Chau (黃泥洲). The cargo of twenty-seven containers went down with the vessel. All eight crewmembers on board were safely rescued by Police launch. There were no loss of life, no injury and no oil pollution reported in this case.
