Crew fatality caused by a deck lifter onboard M.V. Dyvi Adriatic on 30.6.2005

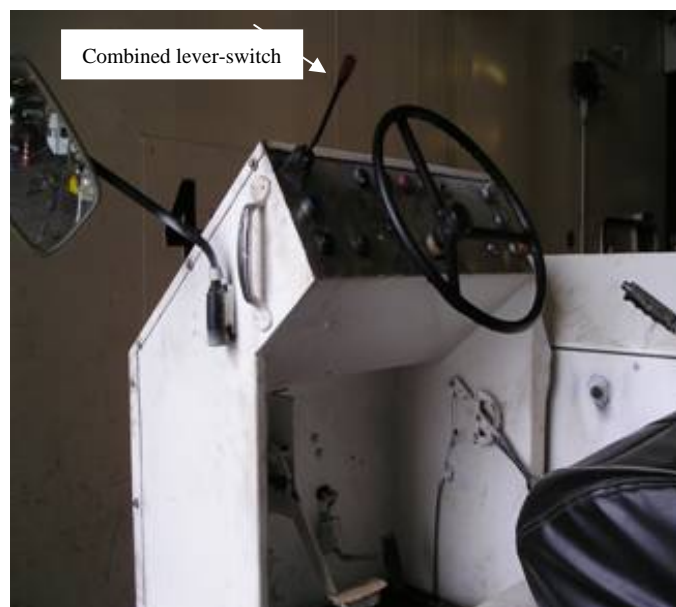
- 2.1 Both deck lifters had been serviced 6 to 8 months ago. The push buttons had been replaced with one combined lever-switch controlling the forward-neutral-backing movements (Fig). It is not known when the modification has been carried out. The lever-switch handle was rather long that could easily be dislocated by coincidence.

- 2.2 The probable cause of the accident was the Deck Cadet dislocated the long handled combined lever-switch by coincident resulted the No. 1 deck lifter moving forward. The moving deck lifter crushed the deceased who stood in between the bulkhead and the front bumper of the No. 1 deck lifter. The crew did not assess adequately the wave condition before carrying out the emergency recovery of mooring ropes at the aft deck.

- 2.3 It was suspected that as the Deck Cadet got off from the deck lifter, his body touched the Combined lever-switch. It triggered the No. 1 deck lifter to move forward since the hand brake is not designed to hold the deck lifter in position with the gear engaged and engine running at full rpm.

The push buttons had been replaced with one combined lever-switch

- 3.1 The driver should ensure area of deck lifter movement is clear of obstructions and personnel.
- 3.2 The driver of the deck lifter should be properly trained and should keep an eye on the accelerator until the deck lifter was fully lifted on the stabilizers.
- 3.3 The management company of Dyvi Adriatic should ensure that all concerned personnel working on board the vessel fully understand the safety instructions and devices for the safe operation of the deck lifter before it is being operated.
- 3.4 The deck lifter should be properly maintained; all defects if found should immediately be repaired and reported to the company. Furthermore, the deck lifter should not be modified without the approval of the maker /company.
