**Report on the Investigation of the Collision between
M.T. SANCHI
and
M.V. CF CRYSTAL
in East China Sea
on 6 January 2018**

**Very Serious Marine Casualty
10 May 2018**

At about 1950LT (1150 UTC) on 6 January 2018, the Panama registered oil tanker SANCHI collided with the Hong Kong (China) registered bulk carrier CF CRYSTAL in East China Sea at approximate position 30°51'.1N / 124°57'.6E. SANCHI, loaded with a cargo of condensate oil, was on her voyage from Assaluyeh, Iran to Daesan, Republic of Korea (ROK). CF CRYSTAL was loaded with sorghum in bulk, bounding from Kalama, USA to Dongguan, China. The collision breached the cargo tanks of SANCHI, resulting in the leakage of condensate oil and consequent fire and explosions and eventual sinking of the vessel. As a result, three crew of SANCHI died and 29 were missing, and resulting pollution occurred. CF CRYSTAL sustained extensive structural damage to her bow and burn damage to other areas. It was a "very serious marine casualty", as defined in the Code of the International Standards and Recommended Practices for a Safety Investigation into a Marine Casualty or Incident (hereinafter referred to as Casualty Investigation Code) (Re

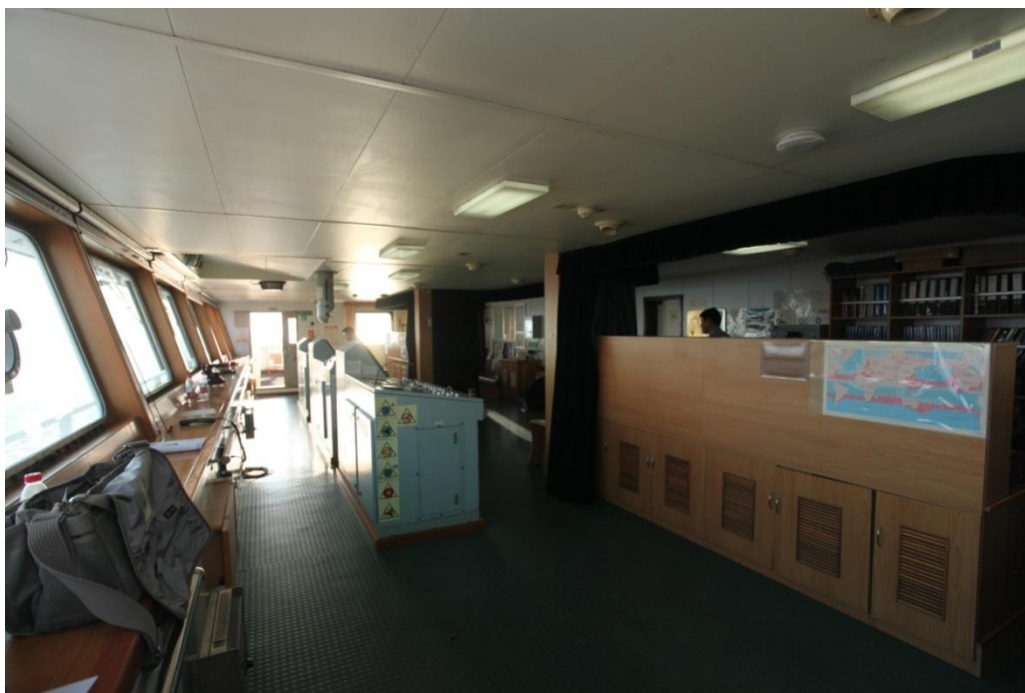
Figure 6-The Bridge of CF CRYSTAL

Navigational equipment: 2 sets of radar with types of FURUNO FAR-2827 and FURUNO FAR-2837S; 1 set of AIS with the type of FURUNO FA-150; 1 set of GPS with the type of FURUNO GP-150; 1 set of Meteorological Fax Receiver with the type of FURUNO FAX-408; 1 set of Navtex Receiver with the type of FURUNO NX-700; Voyage Data Recorder, FURUNOVR-3000; 3 sets of VHF, FURUNO FM-8800S. The ECDIS was not equipped on board.(Figure 6)

According to on-site inspection, the main and auxiliary engine, steering gear, radio equipment and navigational devices of the vessel worked in a normal condition.

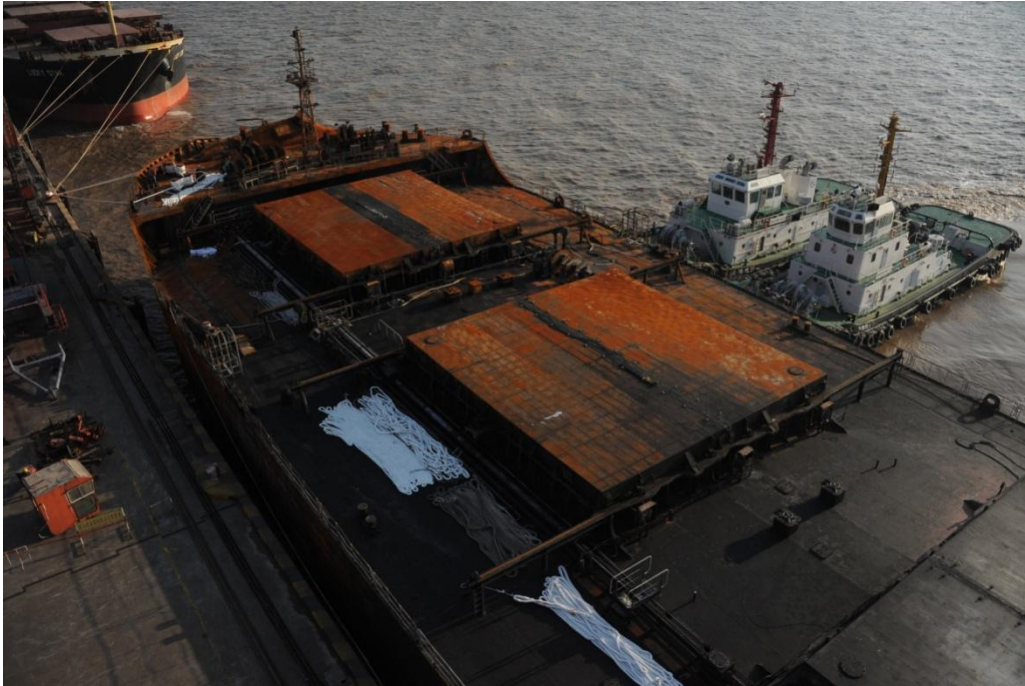
The main deck between the bow and No.3 cargo hold sustained fire causing damage to the windlasses, mooring winches, the front mast and the firefighting box; the whole ship's port side sustained fire damage, and the lifeboat on the port side was damaged. For the starboard side, the parts from the bow to the front of No.3 cargo hold were also burnt. (See Annex F - CF CRYSTAL Survey Report)

Top View from Midship Forward (forward No.3 cargo holds sustained fire)

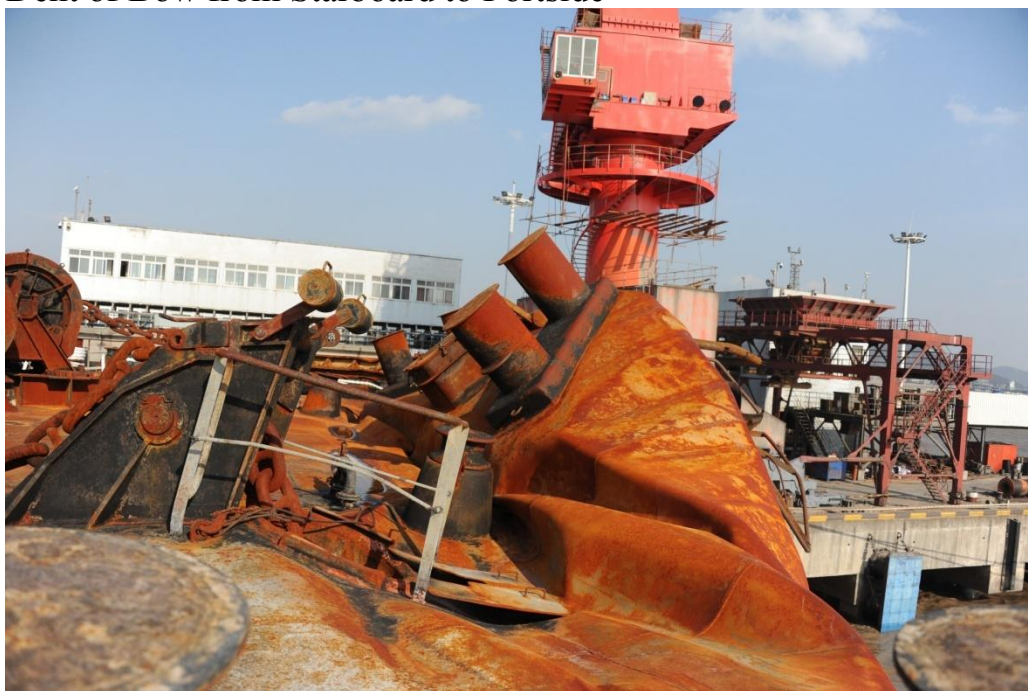
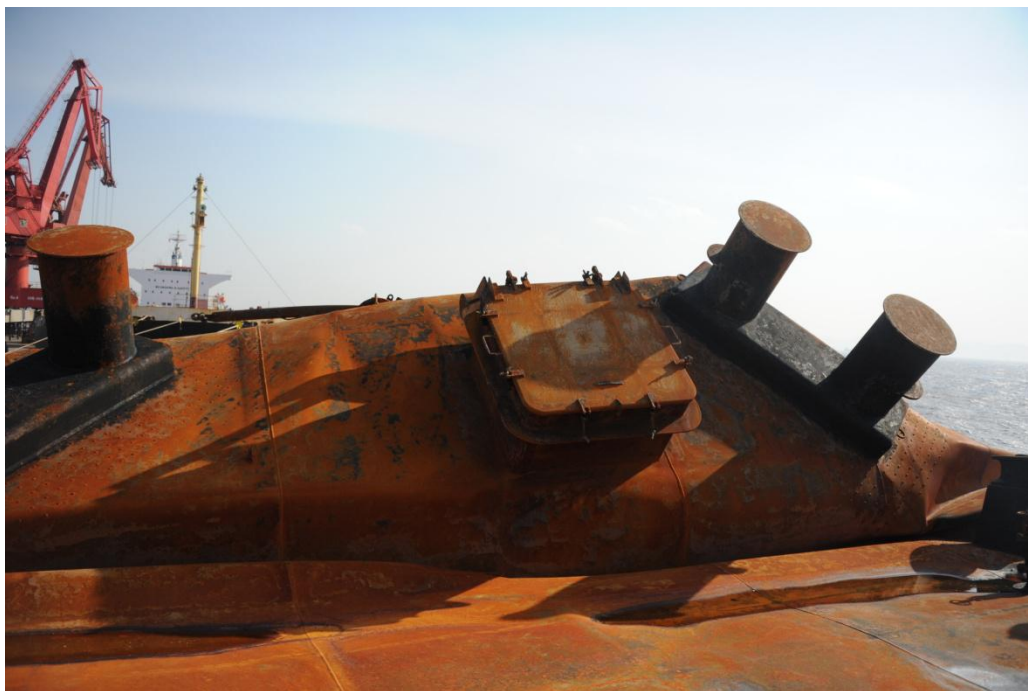
Forecastle deck bending backwards

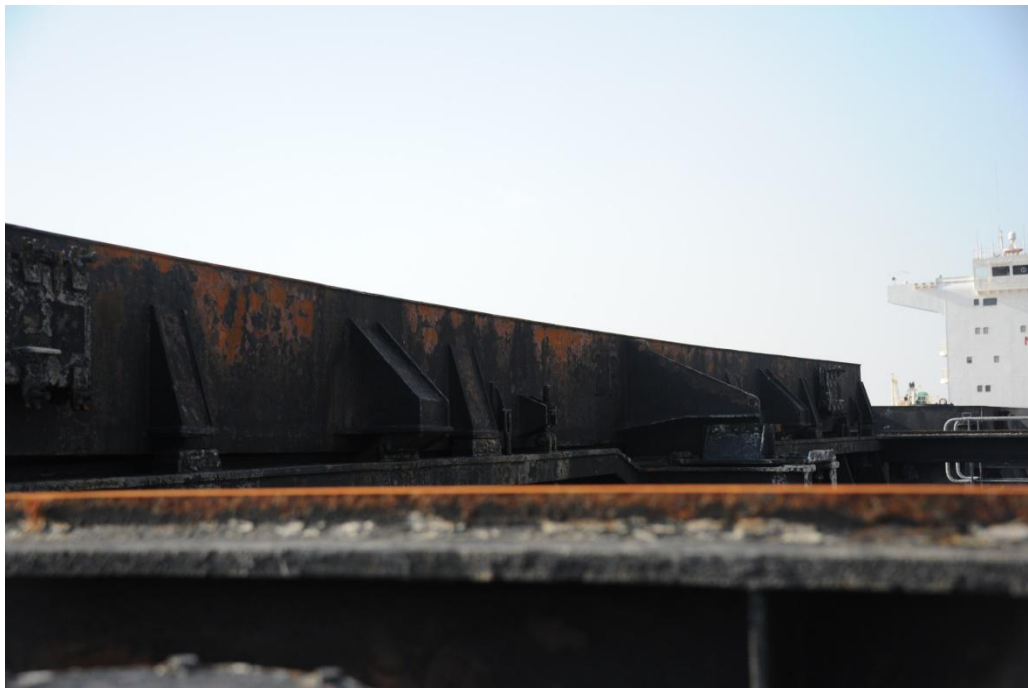
No. 1 Cargo Hold (sustained fire)

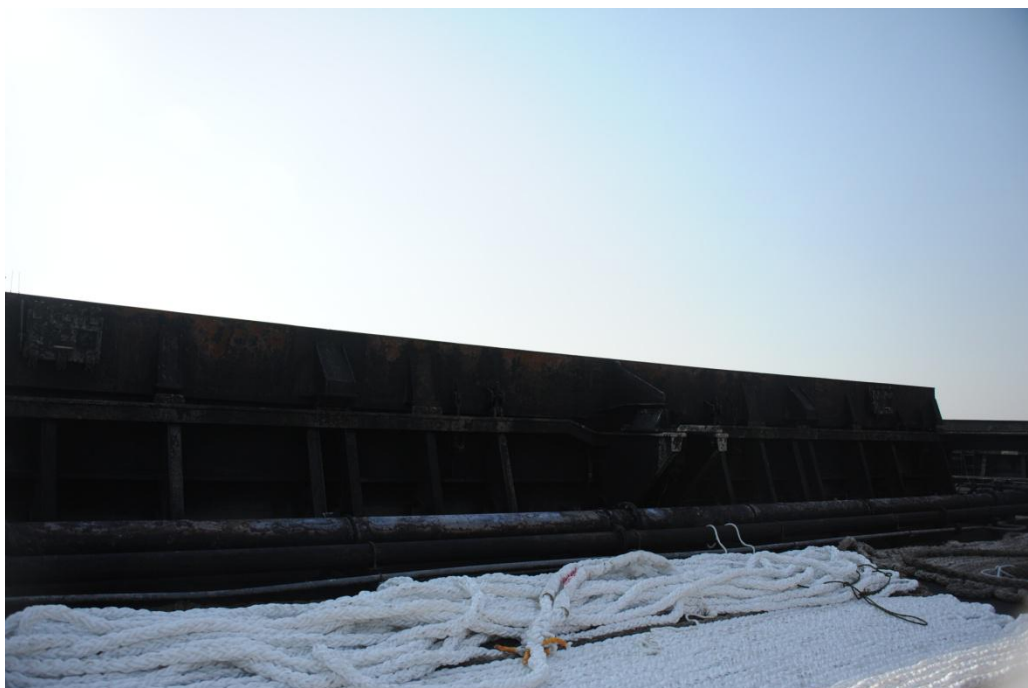
No. 2 Cargo Hold (sustained fire)

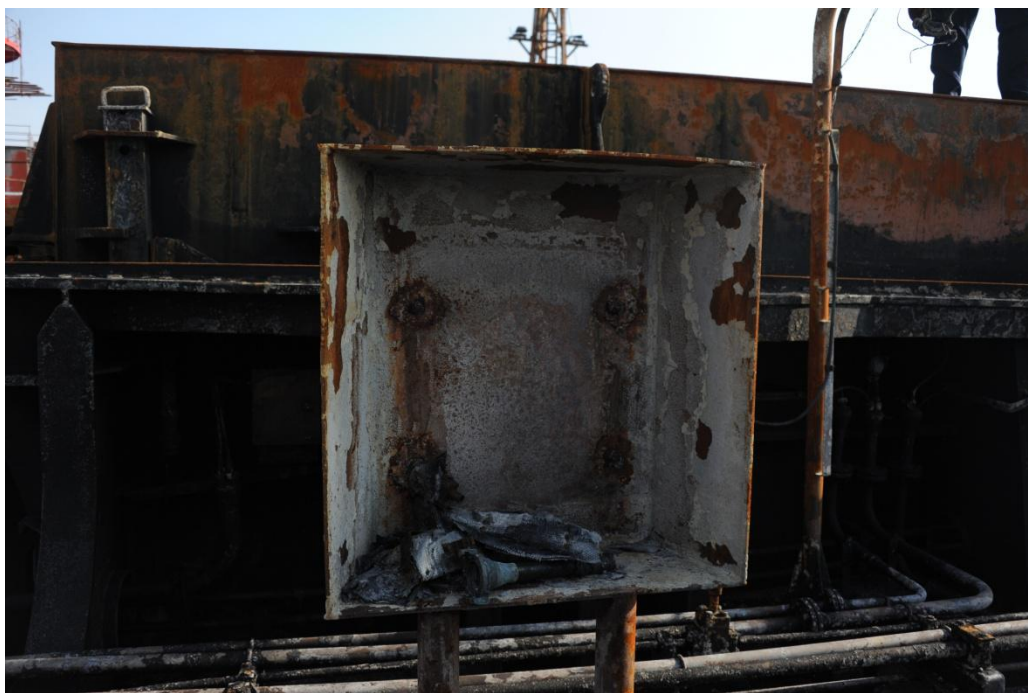
Fire Box Debris

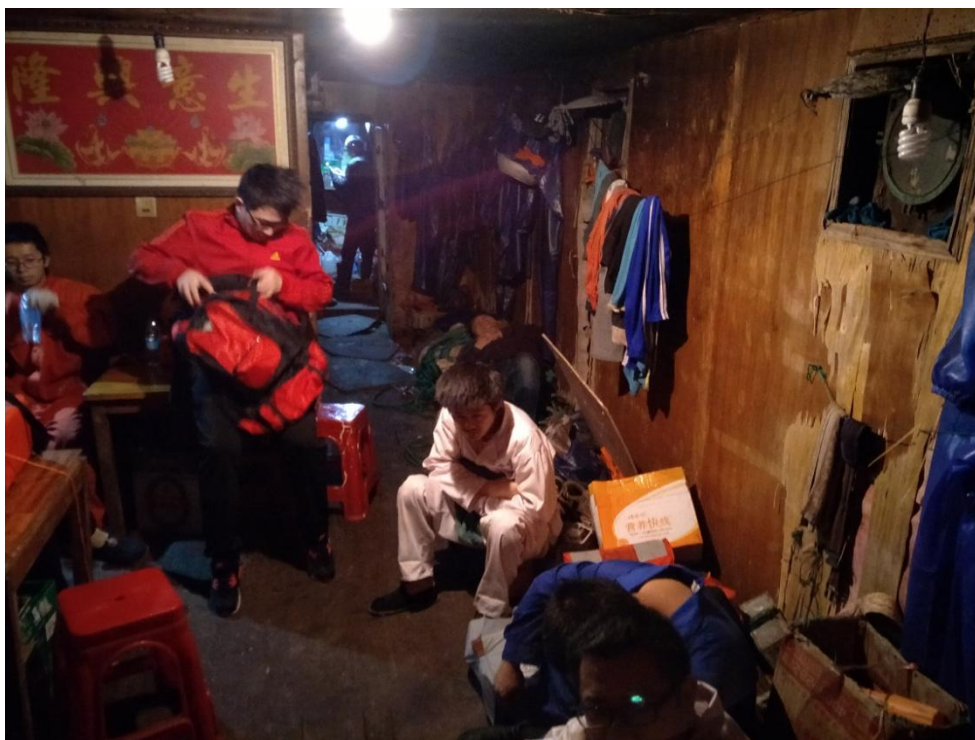
Fire and Explosion after Collision

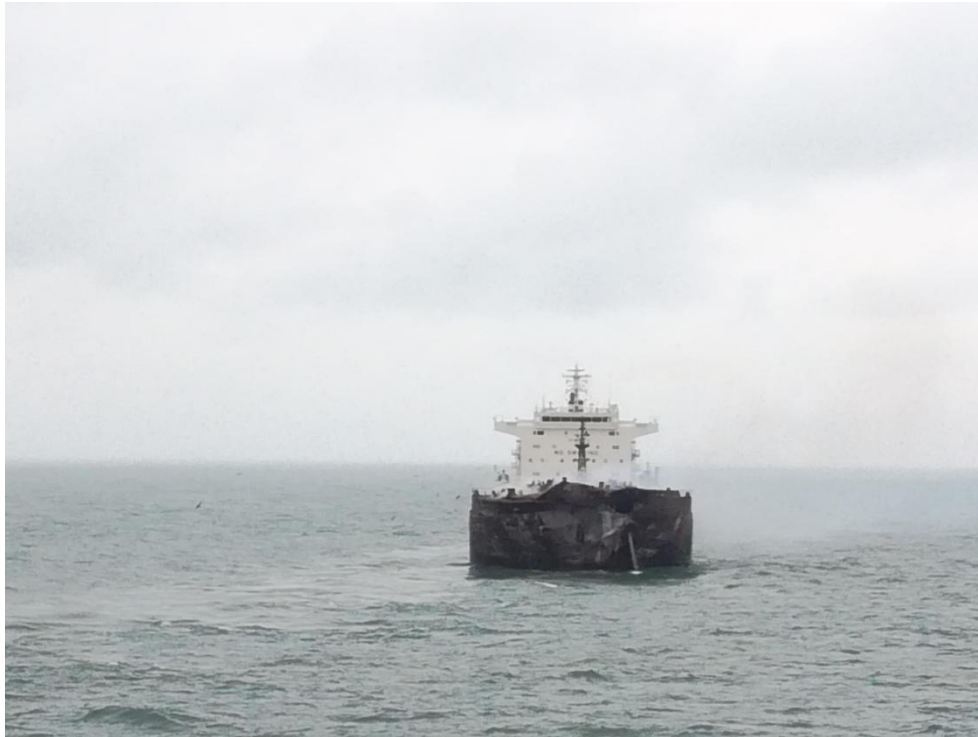
Front View

CF CRYSTAL's condition after abandoned

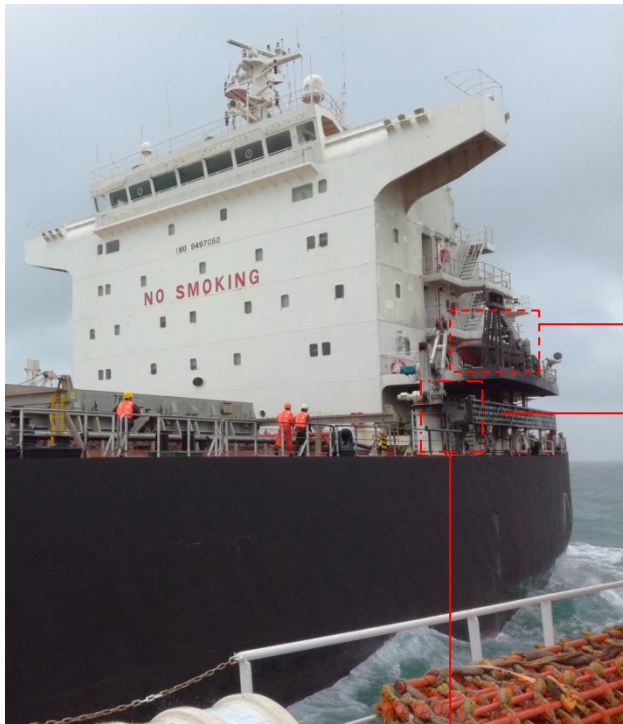
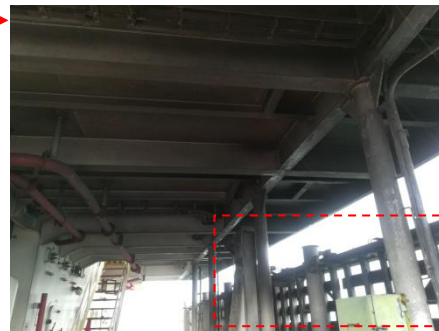
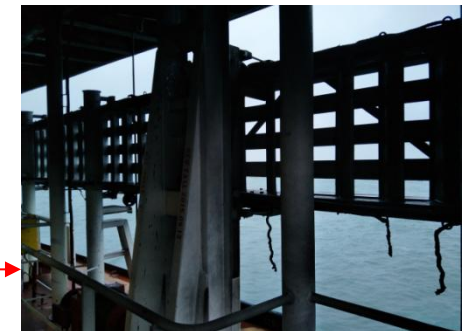
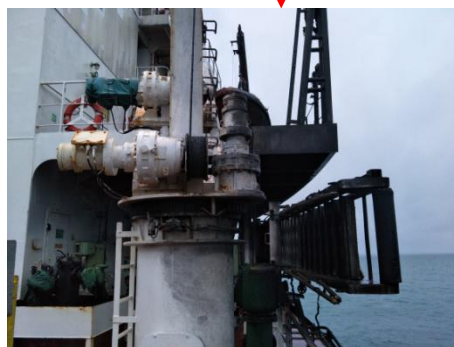
The port side of the accomodation

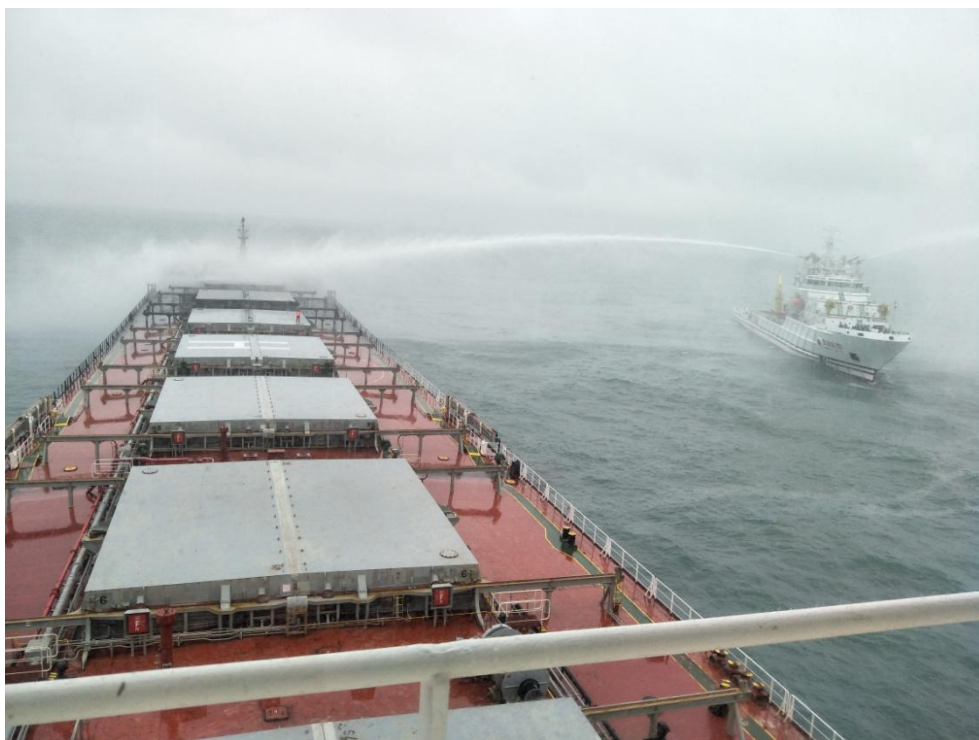
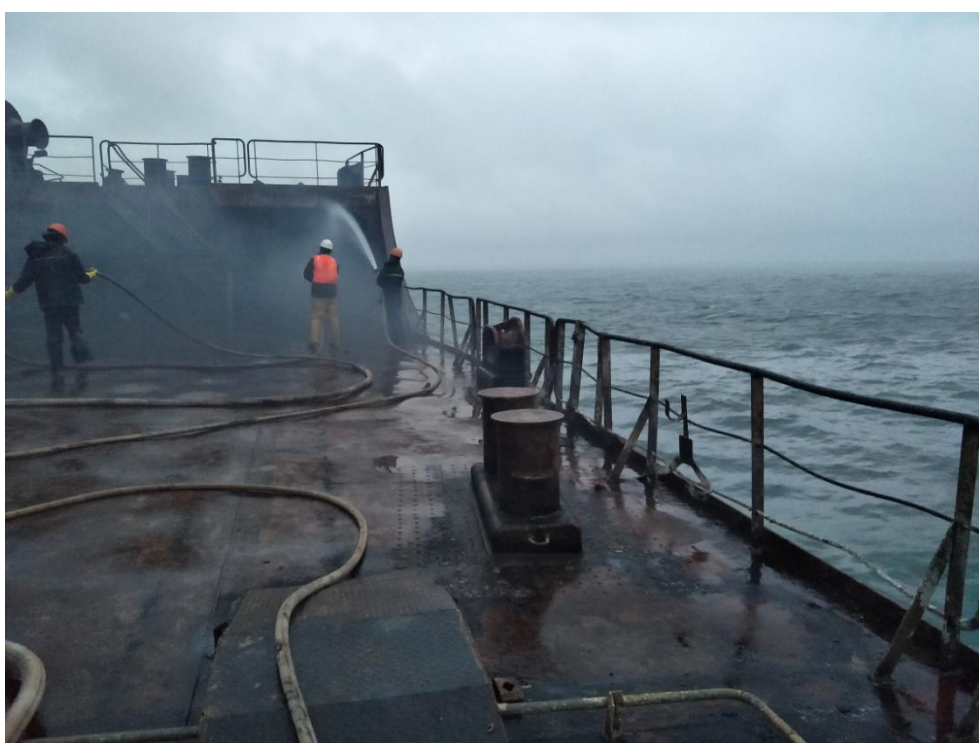
Firefighting by CF CRYSTAL's crew after returning to ship.

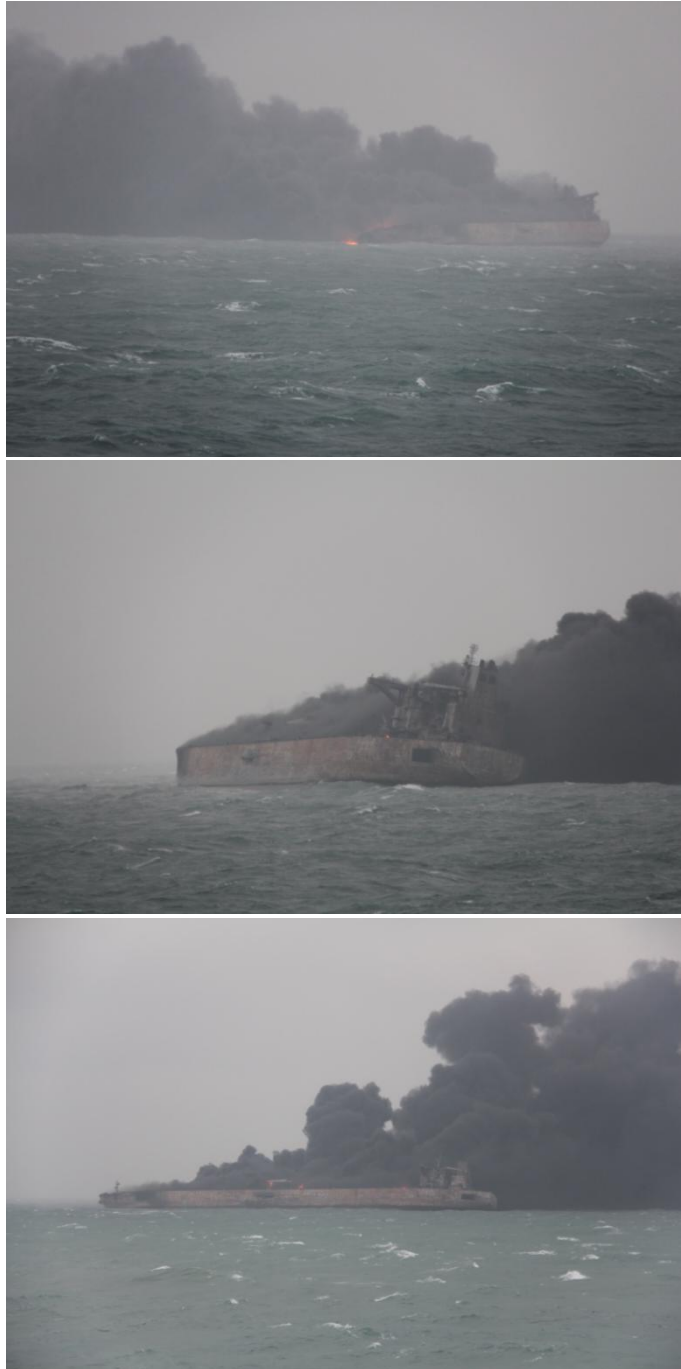
SANCHI on Fire

Fire continued and spread to stern. One body of SANCHI's crew was found and recovered from water by DONGHAIJIU 117.

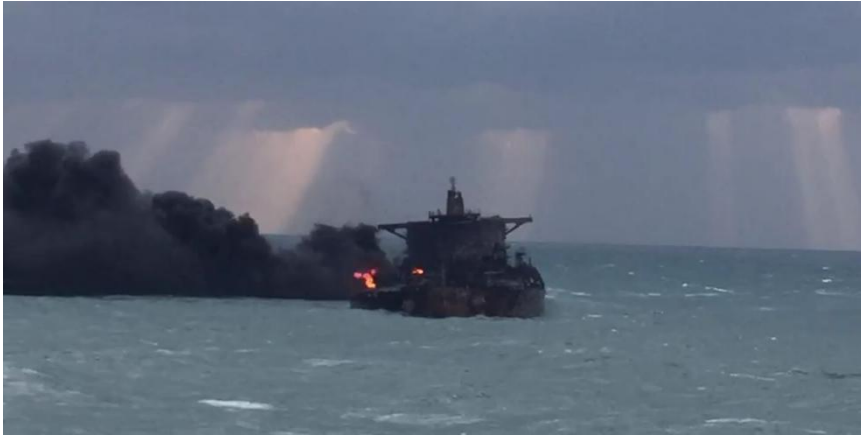
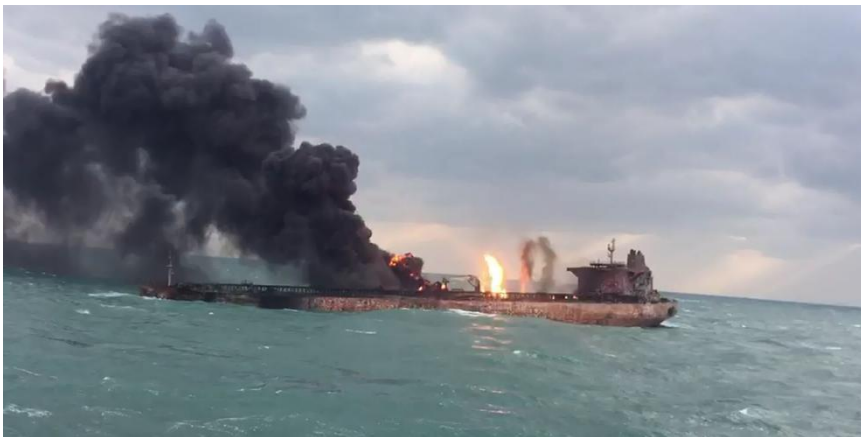
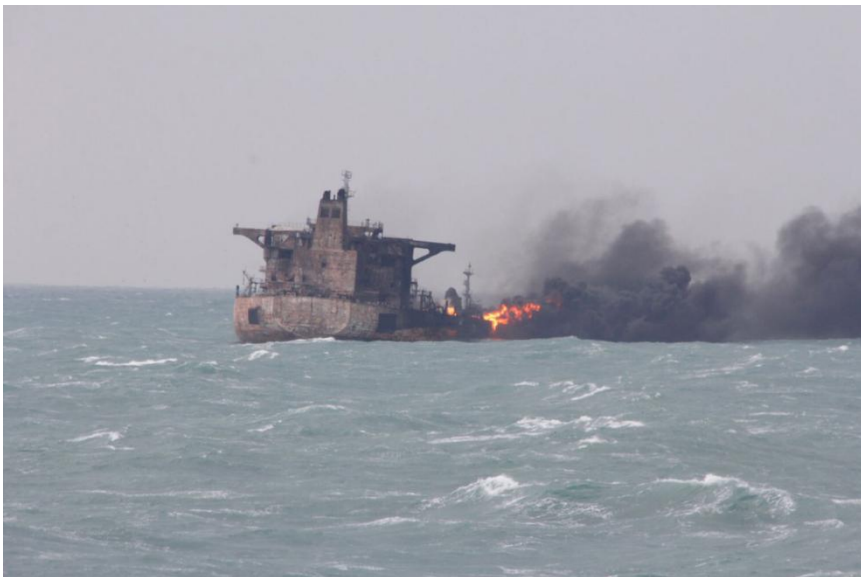
SANCHI on Fire

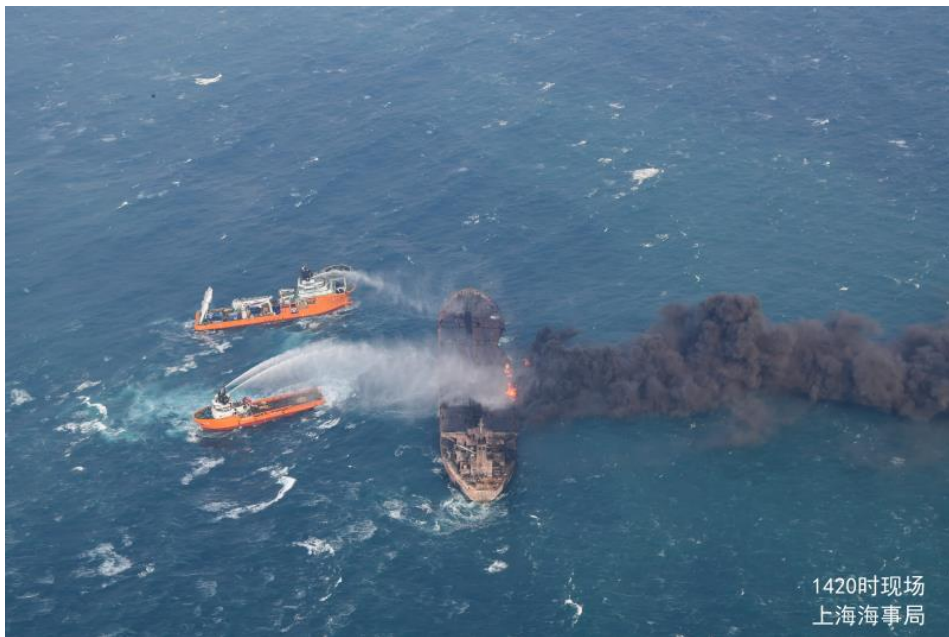
Rescue vessels on site went on firefighting.

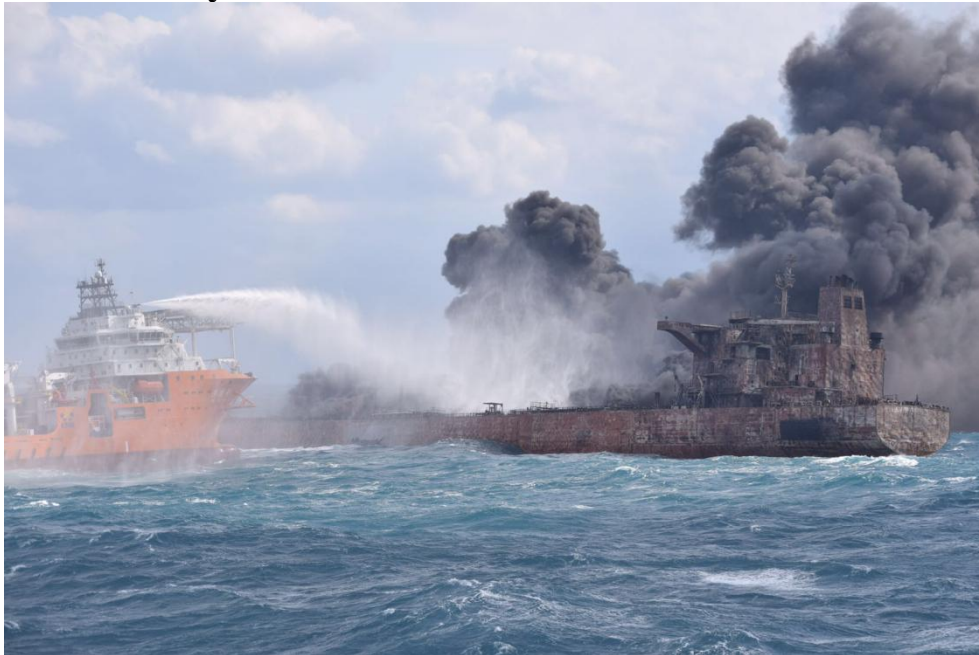
Firefighting by SHENQIAN and DONGHAIJIU 117

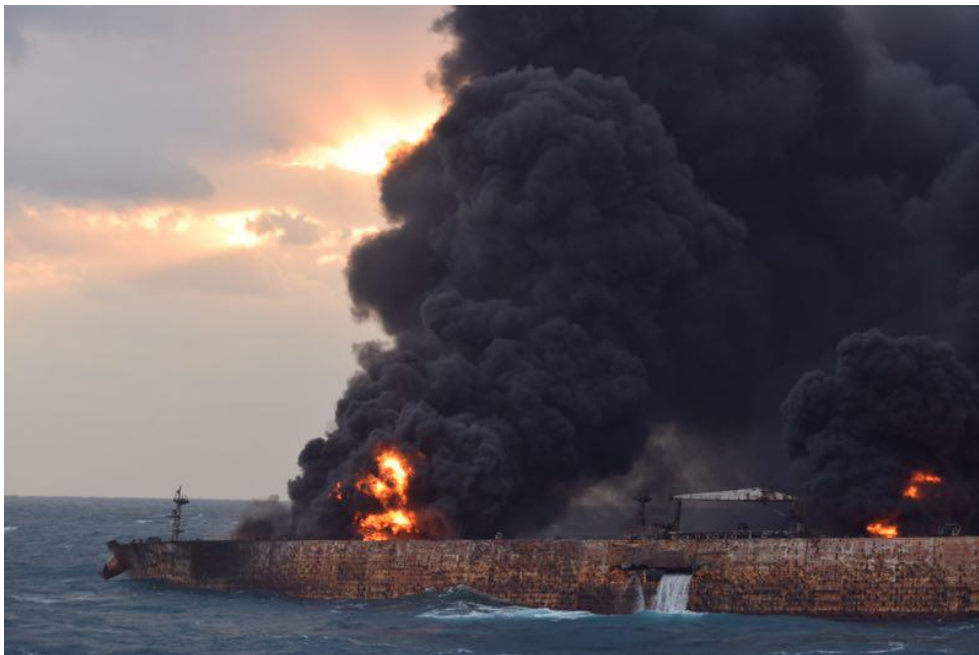
Explosive fire broke out again

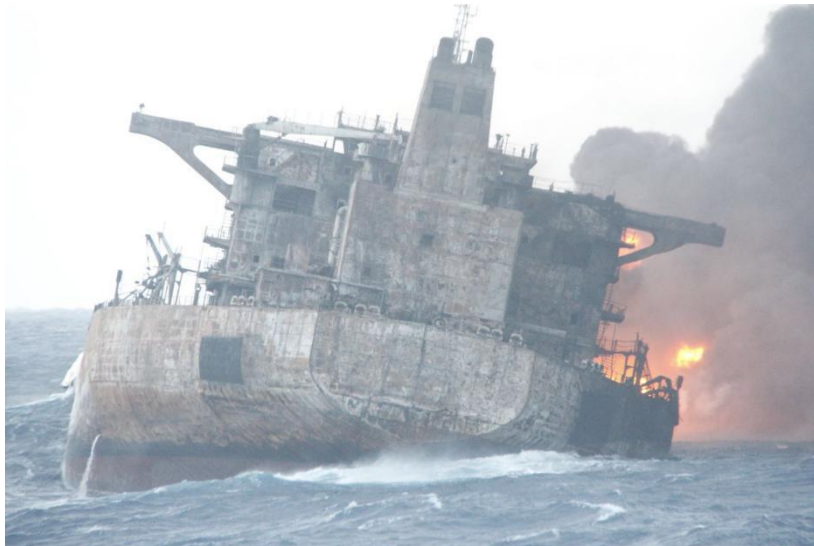
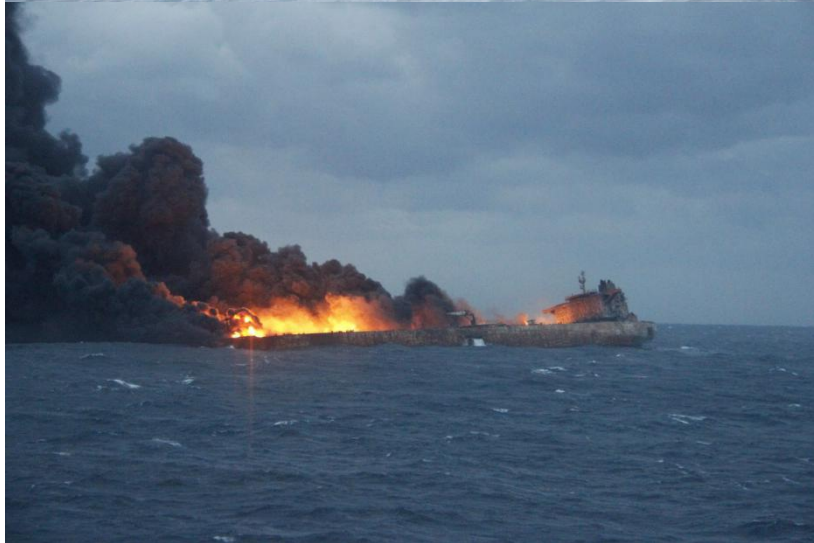
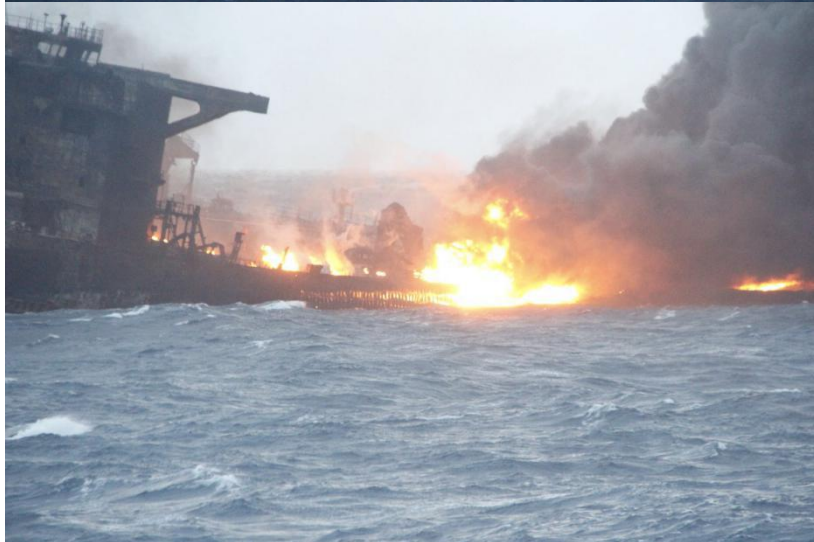
SANCHI still listed to the starboard with intensive fire

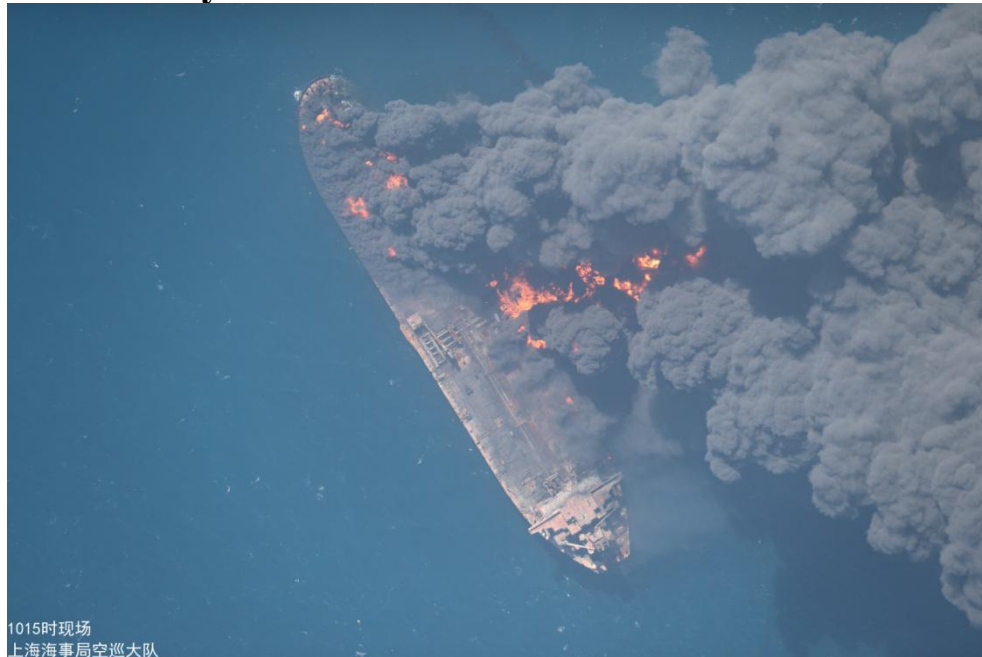
SANCHI on fire

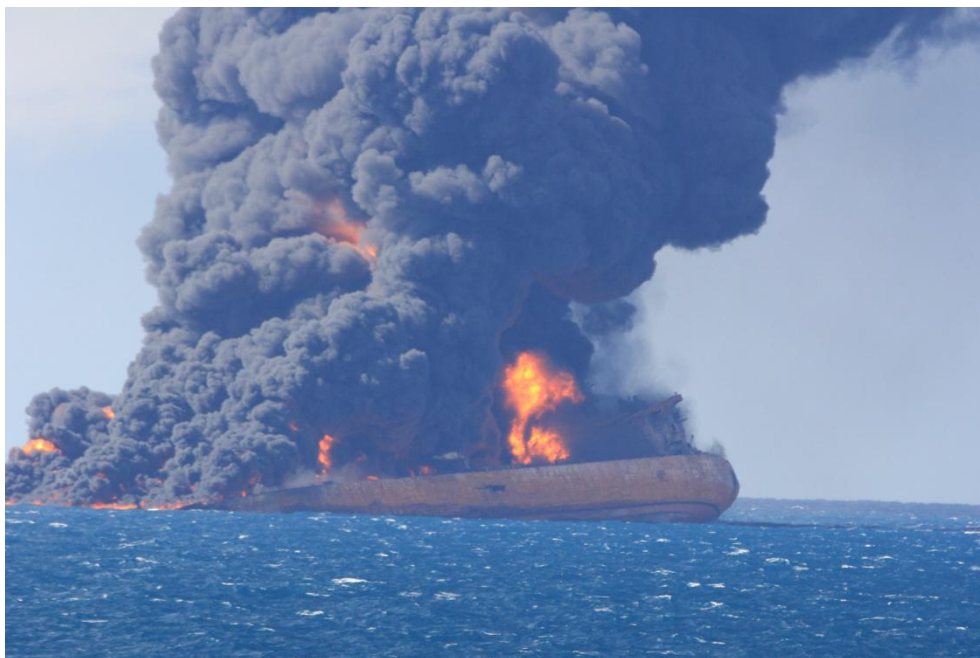
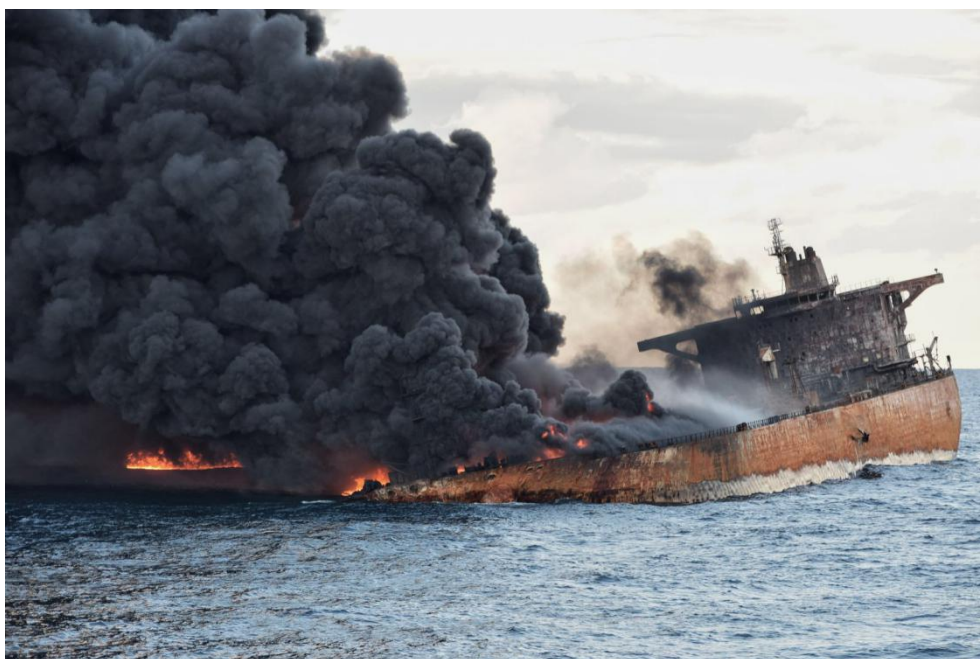
The bow of SANCHI submerged into water.
